Library Construction Report

This report covers the period up to July 30, 2017 .

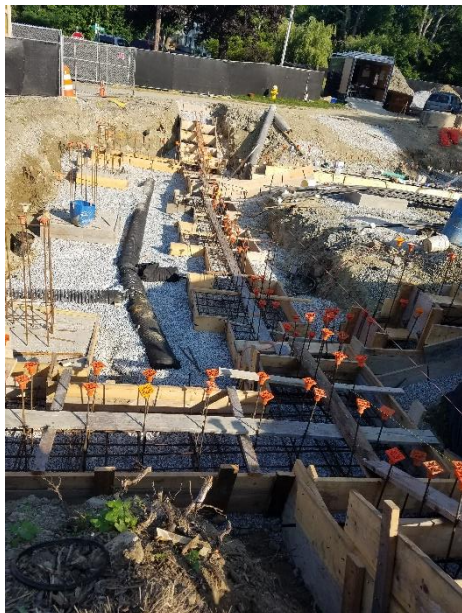
This photo shows the north end of the library wall footings as well as the elevator pit. There was a great deal of discussion about the elevator pit, the proper waterproofing method and the drainage under the pit itself.

Originally planned was a drainage line and crushed stone around the pit. Initially, the builder questioned the need for this because of the sump and the waterproofing, however as we discovered, there was a spring under the pit and this is necessary and was installed and is removing water caused by the spring now and is connected into the underdrain system.

There is also a sump in the pit itself to remove any water that might get into the pit. Mary Beth has identified a potential issue she faced with a similar sump in the construction of the Elementary School. Because the sump could contain hydraulic fluid from the elevator it cannot be drained into the drainage system and needs

to be drained into the sewer system. Because of this it needs a trap to collect any oil before it gets into the sewer. In addition we have to work out the question of possible unmetered water. The issue is being worked on with Scott at the present time.
